The Newsletter

of the National Society for the
Preservation of Covered Bridges, Inc.

Spring 2021

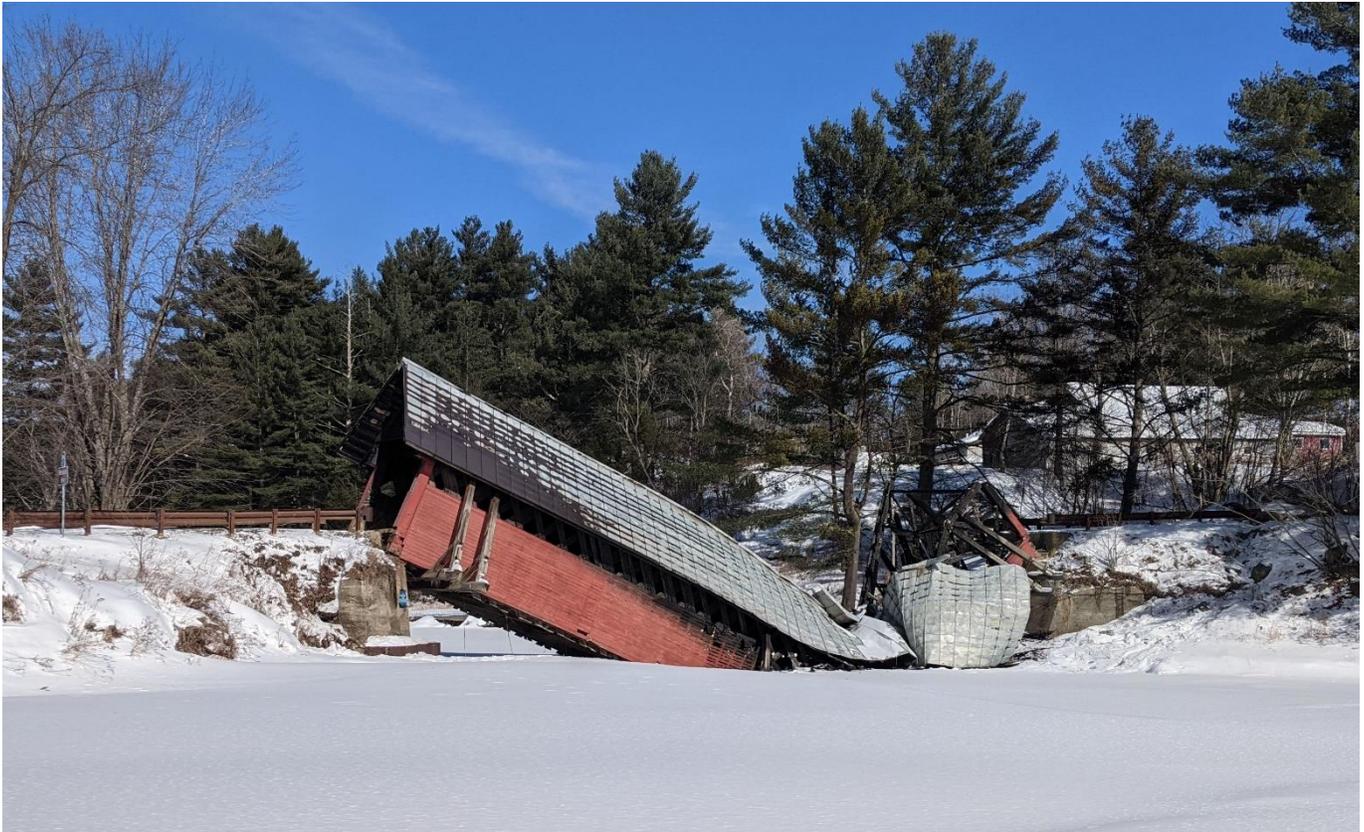
*River Road Bridge (aka School or Upper Bridge)
Troy, Orleans County, Vermont*

If you had not already heard about it, the cover photo informed you of the tragic loss of the River Road Bridge in Troy, Vermont on February 6th after a snowmobile caught fire inside the bridge. As if the fire wasn't bad enough, just a few days later, the bridge was cut up and hauled away. While we completely agree with the town officials that it needed to be removed from the river promptly, I, along with Steve Miyamoto, vice president of the Vermont Covered Bridge Society and others contacted them stressing the uniqueness of that structure and our desire to see as much preserved as possible. Tim Dansereau from Grāton Associates visited the site and spoke with the selectmen and fire chief/road agent. He asked that they keep the bridge as intact as possible during the move so the extent of damage to the trusses could be assessed to determine which pieces may only be charred and not structurally compromised. He also offered to assist with moving the bridge. Jenn and I shared those same sentiments with the fire chief/road agent when we visited the site on February 8th. Unfortunately, our efforts do not seem to have done any good. I attended Troy's Select Board meeting on February 16th where they were primarily gathering and sharing information to help decide how to proceed. We will stay in touch with the community to see where we can help if they choose to build a new covered bridge.

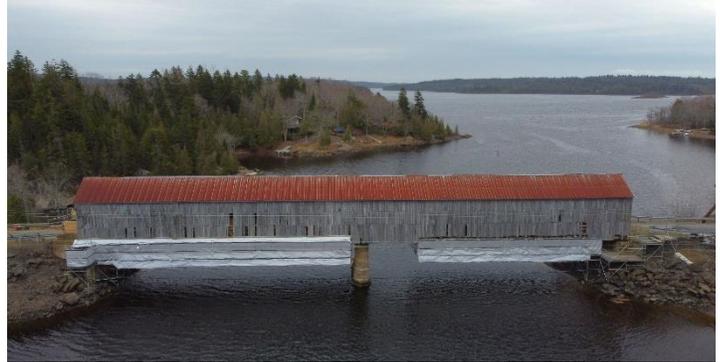
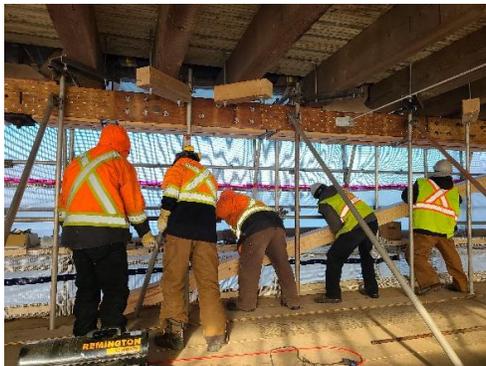
Crew lifting a new floor beam.

The restoration design included the use of high strength fiber reinforcement (FiRP and shear panels), timber laminations and new tension hanger rods. The new design included the replacement of the floor system as well.

Wood Research and Development (WRD) stepped in to restore the 100-year-old bridge, with partner company Timber Restoration Services (TRS) doing the restoration. After doing an inspection using Non-Destructive Testing (NDT), they determined the extent of the internal decay throughout the bridge, the grade and species of the structural elements, the load rating was originally 5 tonnes, and WRD then recommended retrofit solutions, which the client then chose to go with a 30 tonne load rating.

What's great about this project is that WRD designed a lifting beam mechanism to ensure the restoration of the tension tie, or a "hard fix", which means the reinforcement will be fully engaged with dead and live loads. With this design, utilizing the lifting beams, replacing the hanger rods, and providing clamping force, a camber can actually be reinstated in the bridge. Over the years, as the bridge sagged, some of the truss connections were loose. With the reinstatement of camber, the gaps close – reengaging the connections.

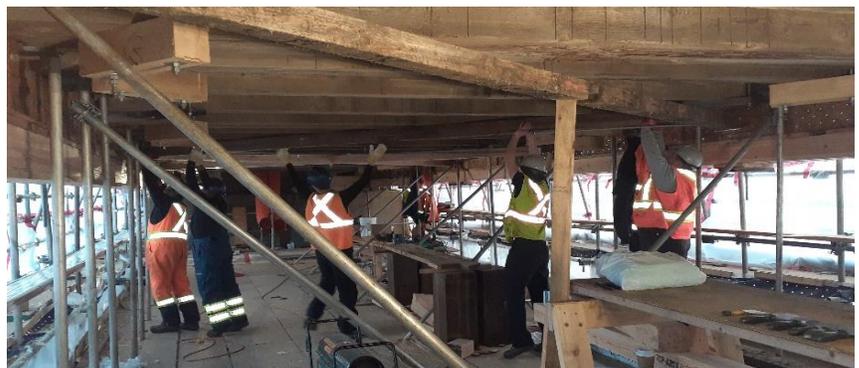
Setting a new floor beam in place.

Can you imagine wood lifting wood? The lifting beams were reinforced glulam. Since timber is lighter in weight, the 35m [115 foot] long lifting girders were rolled right onto the bridge, while maintaining the 5 tonne load rating. Concrete and steel would have been way too heavy. These beams were strong enough to lift the total dead weight of the bridge, and also surplus capacity to fight some of the stiffness of the truss, as well as additional load for the scaffolding, the equipment, and the Timber Restoration Services crew.

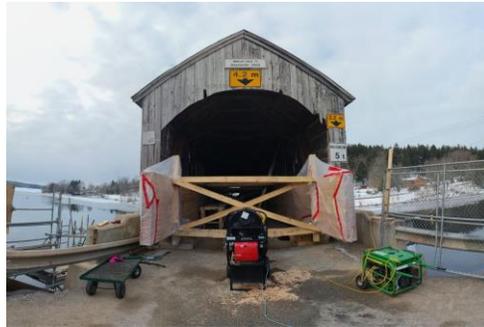
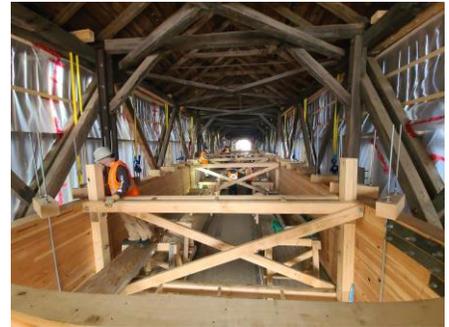
Large timber beams were inserted to support the bridge during repairs. They were also used to reinstate camber back into the structure.

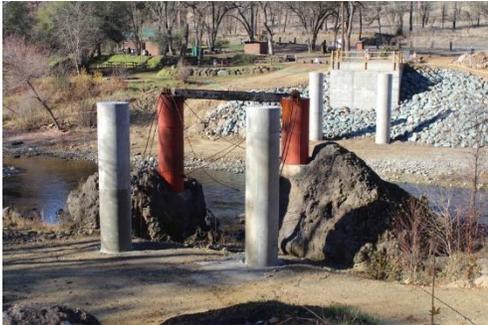
Honey Run Bridge, Butte County – CA/05-04-01

By the end of 2020, the abutments and concrete piers for the replacement bridge were finished to complete Phase I of the project to rebuild the three-span 1887 Honey Run Bridge which was lost on November 8, 2018 during the devastating Camp Fire in Butte County in northern California. The Honey Run Covered Bridge Association (HRCBA) is a non-profit organization which is leading the fundraising effort for the bridge's replacement. Phase II will start around midsummer to construct the trusses and flooring. Phase III will be the siding and roofing. All three phases will cost a total

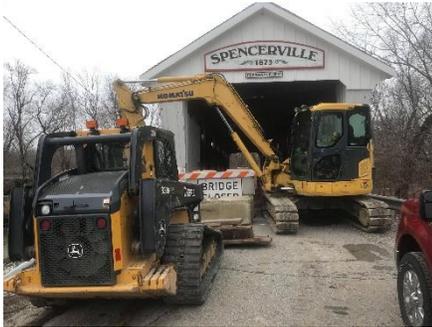
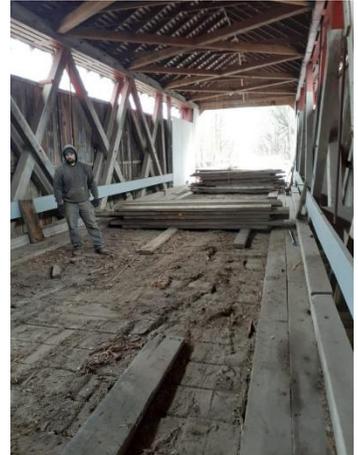
the restoration of this bridge. The flooring has been taken up to make way for new decking. As you can see, there was a lot of dirt and leaves accumulated under those boards! It will need a good sweeping to remove all of that. The old boards look to be in good shape and were delivered to a secure location. The Friends of Spencerville Covered Bridge will use them for fundraising efforts later

this year. On January 18th, the County Commissioners voted to spend \$45,000 to construct new concrete wing walls at both ends of the bridge while it is raised for repairs. The repair project was awarded to R.G. Zachrich Construction of Defiance, Ohio, for \$269,000 and is scheduled to be completed in April. The 1873 bridge has been closed to traffic since October 2018. Fire retardant donated by NSPCB will be applied after the repair work is completed. *Additional news from The Star, January 19, 2021. Photos provided by Don Diehl and Cheri Bushee*

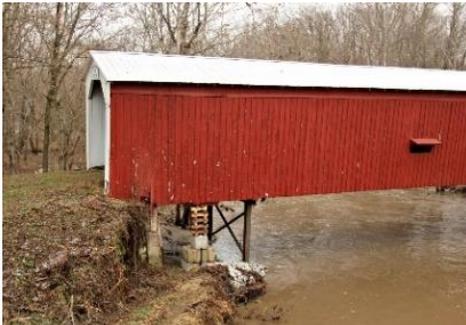
Cades Mill Bridge, Fountain County – IN/14-23-02

The Fountain County Art Council/ Historic Committee continues with the conservation project of the 1854 Cades Mill covered bridge which is the oldest covered bridge in the state of Indiana that remains on its original site. A phased plan to address replacing / repairing the lower chords, replace siding as needed, and repainting has been put into place. A letter of intent has been signed with CLR Construction of Bloomington, Indiana who has a long history of covered bridge restoration.

To date, the county has removed several trees that were hanging over the bridge and placed riprap on the north entry. Stabilization was completed in 2020. National Register Listing is pending. A projected starting date is summer of 2021. The estimated cost of \$405,000 will be raised thru private donations, solicitations, and grants. The citizens of Fountain County, Indiana have an appreciation of the historical and economic impact of conserving this bridge. The Fountain County Historical Committee plans to address the conservation of the Wallace covered bridge once Cade's Mil is completed.

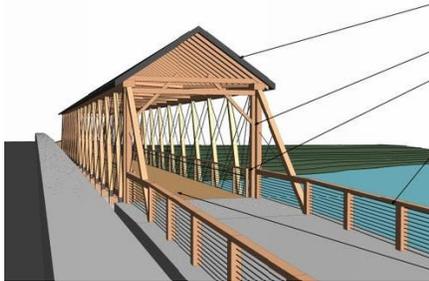
Diagram of reconstructed Bell Ford Covered Bridge Courtesy Hamilton County Parks and Recreation

The Summer and Fall 2019 editions of this Newsletter reported on the planned reconstruction of the Bell's Ford Bridge in Hamilton County. The NSPCB and Indiana Covered Bridge Society are both consulting parties to the design of the project. The 332-foot, 2-span, bridge was originally built in Jackson County in 1869 by Robert Pattison and was the last known Post truss covered bridge. The

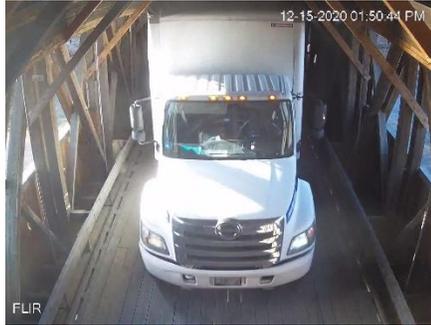
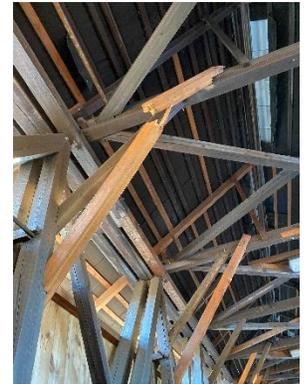
Blair Bridge, Campton, Grafton County – NH/29-05-09

Campton Police reported that on December 15, 2020, a box truck drove across the bridge disregarding the posted height and weight limits and damaging 17 wooden braces.

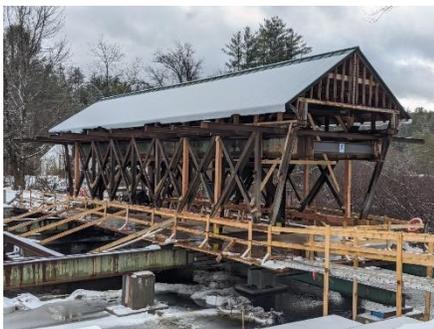
Temporarily relocated bridge.

Previous issues have described the work occurring at this bridge. Since our last update, the southern abutment has been rebuilt at its new height. The abutment is made of concrete that has been faced with the stones from the former abutment. It appears that the concrete work on the northern abutment is complete. That one will be faced with new granite blocks. The lower chords and a small number of truss timbers have been replaced while some others have had deteriorated sections cut out and new wood spliced in. Work stopped for the winter and will pick up again about the time you receive this issue. *Photos taken in mid-January by Bill & Jenn Caswell.*

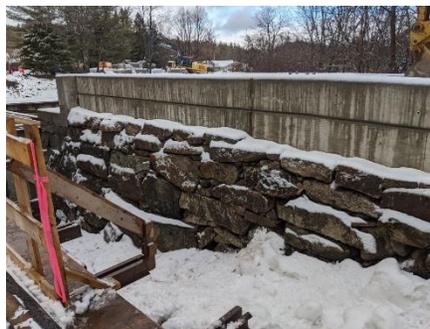
New southern abutment.

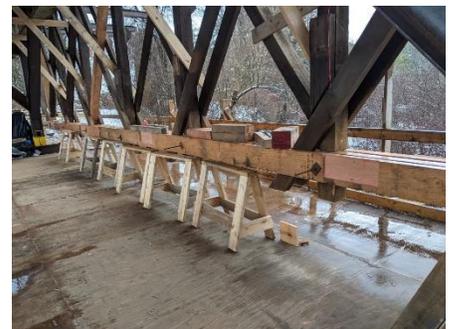
New lower chord in place.

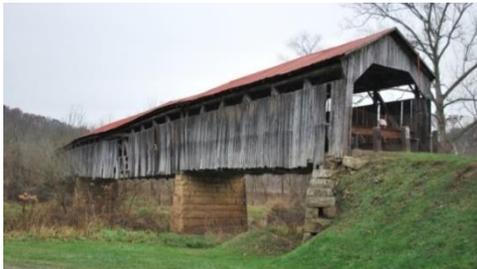
Jim Smedley Photo

As we have reported in prior Newsletters, plans were in place to restore this bridge with a grant for \$950,000 when the first span collapsed on July 5, 2019. According to a report in the Times-Leader of December 26th, Monroe County officials are hoping to use locally grown and county-owned timber to rebuild the bridge saving the county thousands of dollars on the project. Timber specialist Rudy Christian and Knowlton Covered Bridge Parks Board President Hebert Piatt identified usable timber in a county-owned property in Center Township. They located 115 white oak trees, most of what would be needed. In addition to saving costs, county officials feel that using locally sourced materials will also preserve the historic value of the bridge. The timber will be harvested and stored this winter. Officials are hoping to begin the restoration project sometime in the spring. The three photos here show the progression from a complete bridge to the first span collapsing to its condition as of October 2020.

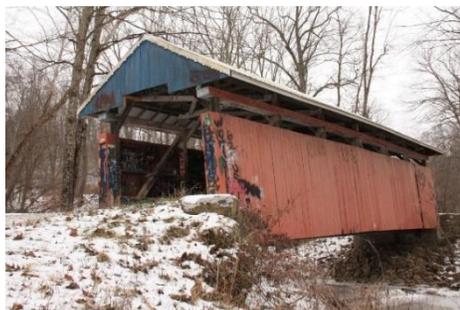
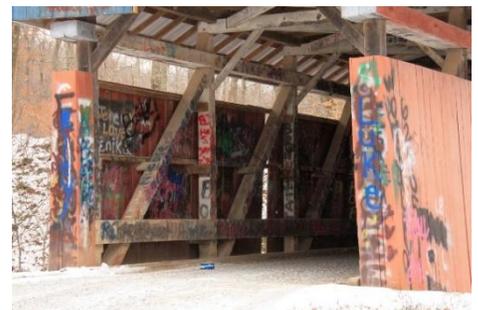
Jack’s Hollow Bridge, Perry County – OH/35-64-05

attention, we received these photos taken in December 2020 from new member Jeff Griffen. NSPCB sent letter expressing concerns about this bridge to the Perry County commissioners in July 2014. Apparently, that did not have any impact. Another letter noting our concerns for this structure went out to them in

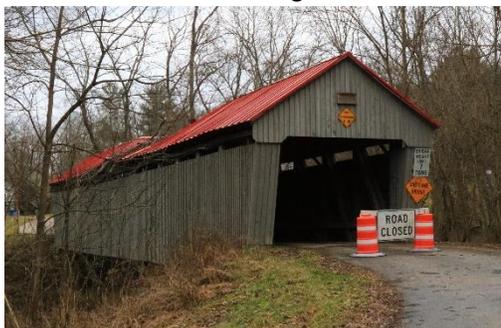
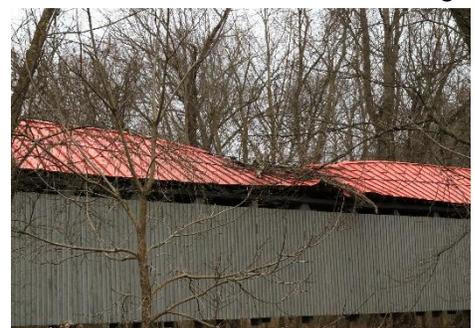
We received these photos from member Jeff Griffen on January 9th showing damage to the bridge’s roof from a tree falling on it. We contacted County Engineer Roy DePue who indicated that the damage

was evaluated and the truss structure was not impacted. The roof systems sustained all the damage. Drawings and specifications for the repair are in place and funding was in place. The repair was planned for last summer, but funds needed to be diverted to essential

services impacted by COVID-19. Funding has again been secured and the repairs should be completed during the 2021 construction season.

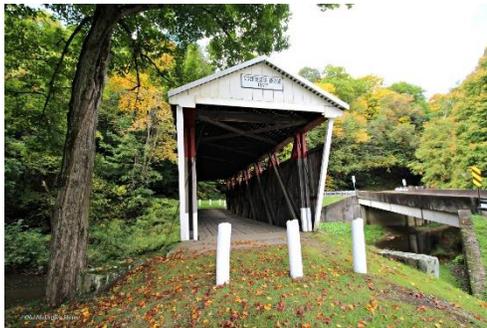
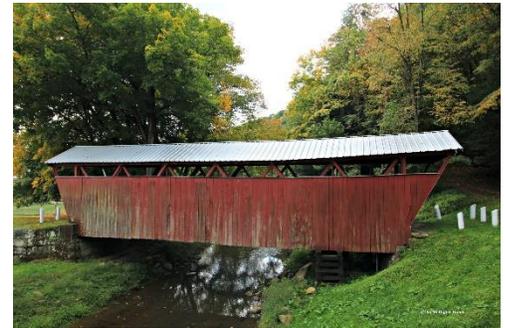
Kintersburg Bridge, Indiana County – PA/38-32-05

We received a report that this bridge was in need of some attention. After contacting local officials for more information, we received a nice summary from Ed Patterson, Director of Indiana County Parks & Trails. Mr. Patterson noted that his group assumed maintenance responsibility for the county's covered bridges in 2009. Since then they have applied for grants to the Federal Highway Administration on two different occasions to obtain the estimated \$605,000 necessary to properly restore the bridge. Neither grant request has been successful. In the

meantime they have installed cribbing on each end to help support the structure. This is only intended to be a temporary measure until funding is available. They have also replaced some of the siding and made minor repairs to the trusses. They were informed about the Society's fire retardant program and are interested in participating. *Photos by Greg McDuffee.*

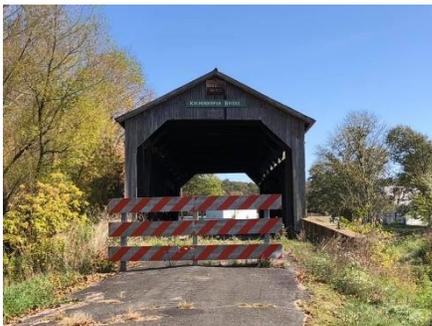
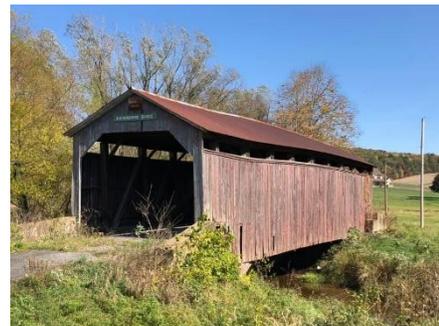
Kochenderfer Bridge, Perry County – PA/38-50-09

We had a report that this bridge was in need of some attention. We have contacted the county commissioners to gather more information. The single-span, 71 foot long bridge crossing Buffalo Creek was built in 1919 and bypassed in 1986. *Photos by Gloria Smedley.*

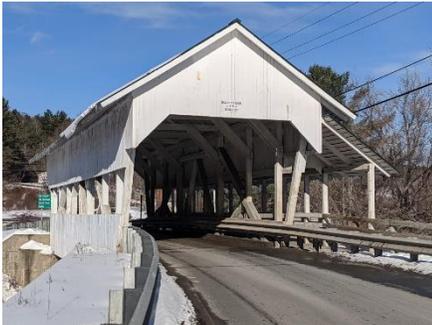
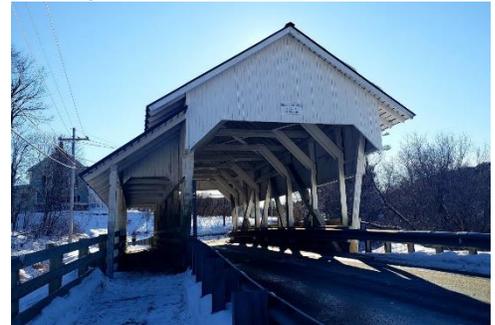
Miller's Run or Bradley Bridge, Lyndonville, Caledonia County – VT/45-03-06#2

Shortly after noon on February 4th, Lyndon Police received a call that two Penske box trucks had driven through the bridge causing some damage. The trucks were located at B&B Towing in Lyndon. The drivers, Michael Giles, 59, of Massachusetts, and FNU Agbortoko Achuo Tabong, 62, of New Hampshire were

each issued \$2,000 tickets. The bridge was not structurally compromised and remained open to traffic. Bill and Jenn visited on February 8th to find that the damage had already been repaired. This bridge has had a number of similar incidents over the past couple years. The most recent one,

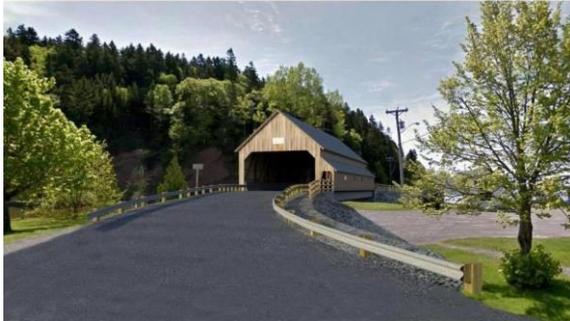
Although the CBCANB, NSPCB and members of both organizations have sent letters protesting the removal of the heritage structure to local, provincial and federal representatives, it appears that their replacement plan is moving forward. This drawing showing the planned design is being distributed by the Department of Transportation.

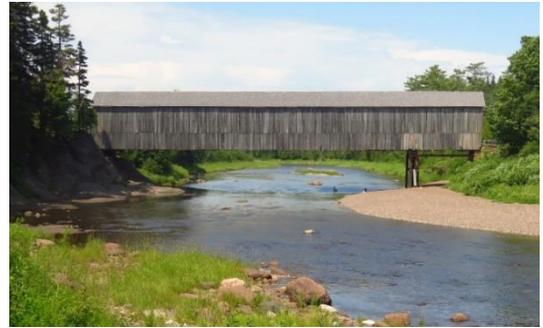
Hammond River #3 (Smithtown) Bridge, Kings County – NB/55-06-24

In early January we received word that the work reported in the previous issue is now complete. The project replaced floor beams and the wooden decking plus added an epoxy to extend the life of the deck boards. The cedar roof shingles were also to be replaced. The 187-foot (57 meter) long Howe truss bridge was built in 1914. *Photo by Bill Caswell.*

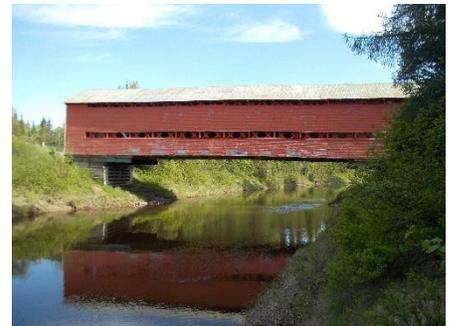
Pont de l'Original, Abitibi-Témiscamingue Region – QC/61-01-18

On January 14th, the Québec Ministry of Transport announced that this bridge was being closed to all traffic after a recent inspection and a detour route was posted. An article published in *Le Citoyen* on January 22nd provided additional details. The bridge was closed because the abutments are in poor condition. The closure is preventive to keep the structure from deteriorating further. Repair work has not yet been scheduled. This will have an impact on the area as the bridge is part of Route 395, a heavily travelled section of the road connecting Amos and Lebel-sur-Quévillon. The 109-foot-long Town truss structure was built over the Laflamme River in 1942. The closure was due to concerns about the poor condition of the bridge's abutments. Plans for repairs have not yet been announced. *Photo by Simon Pratte.*

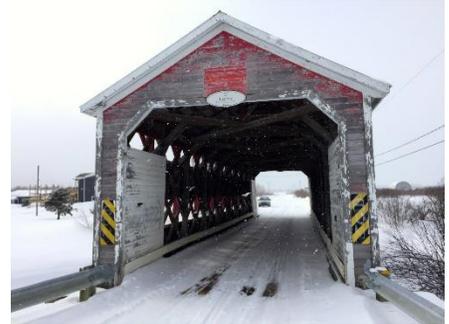
Pont Leclerc, Abitibi-Témiscamingue Region – QC/61-02-05

Last fall, the MTQ announced that this bridge would be closed between September 17, 2020 and June 22, 2021 for restoration work. However, as of February 5th, it was still open. Pascal conveyed a report from Sylvie Crépeault who noted that some of the timbers have been tagged with either bright green or blue paint. It isn't yet known if these markings indicate timbers to be repaired, replaced or have some other meaning. The 81 foot (25 meter) long bridge was built in 1927. Like most bridges in the area, it uses a variation of the Town truss constructed by the Ministry of Colonization. Photo by *Pascal Conner*.

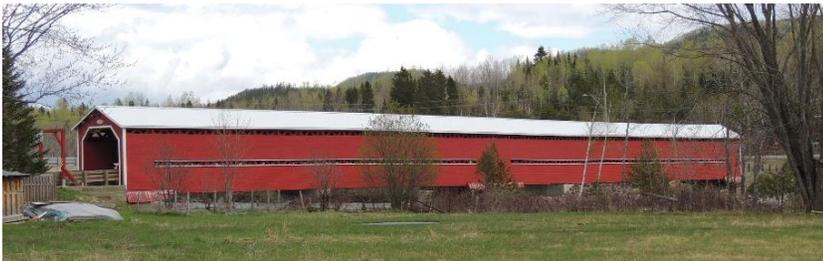
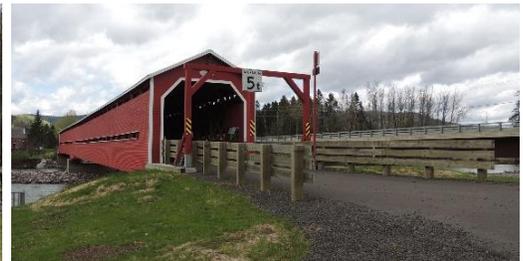
Pont de St-Edgar, Gaspésie Region – QC/61-10-05

The particularly mild temperature at the beginning of December caused several rivers to overflow in the Gaspé region. During that high water situation, some siding of the bridge was damaged by trees and debris washed downstream. Hopefully the damage will be repaired next summer. The two-span Town variation truss bridge was built in 1938. It is 293 feet (89 meters) long. Photos by *Gérald Arbour*.

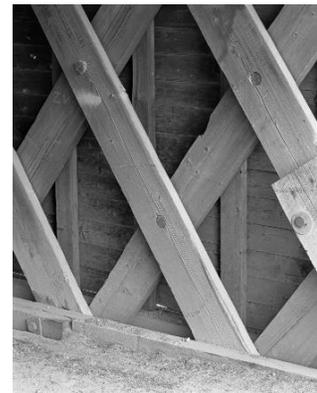
Joseph Conwill Photo of Single Pin Connection
